What in the World am I looking at?

CHRIST CHURCH PARISH FELLOWSHIP HALL RESTORATION PROJECT

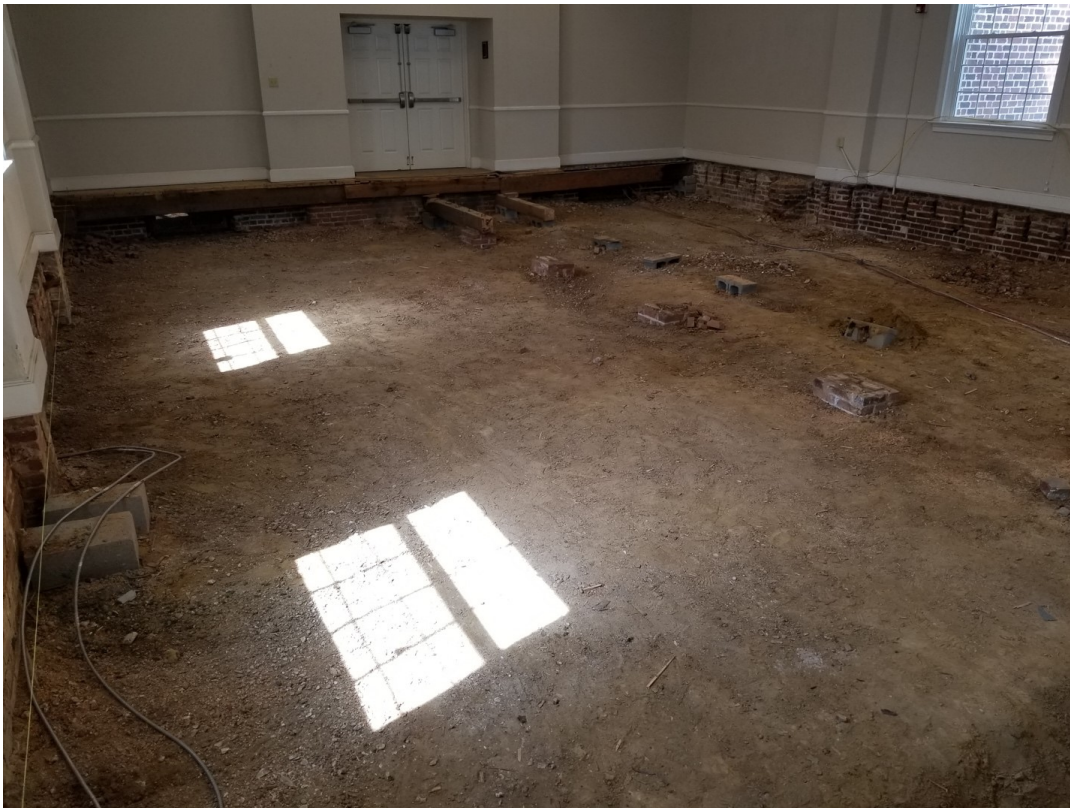
From the start of removing the flooring, we realized that we may be dealing with some significant issues as this photo indicates. Underneath the plywood floor, was a patchwork of scrap wood that was used to “level” the floor.

Further removal indicated a number of damaged joists that were literally falling down as the floor was being removed. This prompted us to remove more of the floor to determine the real extent of the damage. As you can see from the photos, some of the joists were severely damaged. The support for the floor consisted of one row of six piers that supported the main beam that ran down the center of the room. The vast majority of joists had either ter-

mite damage to the extent they would crumble in your hand or break into pieces when they were lifted.

If it wasn't termites it was severe moisture rot near the brick foundation so that the smallest amount of pressure would break the joist.

At this point, we removed the floor from outside wall to outside wall from the double entry doors to where the basement starts. That's an area of roughly 1200 square feet that became a major reconstruction project rather than a small area floor repair. It also meant we had to comply with the current building codes, which, in this case, requires us to design the floor for a loading of 100 pounds per square foot. So now there will be four rows of 6 piers each that support four main beams with 36 thirty-one-foot wooden I-beams that go wall to wall.
